TOP SECRET CHESS RUFF PHOTOGRAPHIC INTERPRETATION REPORT UNIDENTIFIED ACTIVITY AT SA-1 SAM SITES. MOSCOW, USSR NPIC/R-836/64 September 1964 NATIONAL PHOTOGRAPHIC INTERPRETATION CENTER TOP SECRET CHESS RUFF

This report is in response to requirements for information concerning the nature, type, and location of unidentified activity observed at SA-1 SAM sites in the Moscow area since

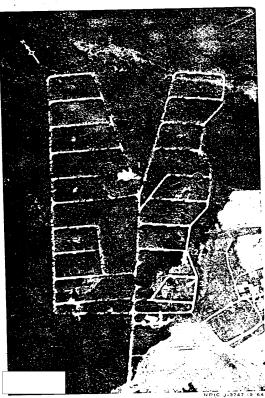
FIGURE 3. MOSCOW SAM SITE CO2-1.

At the perimeter road, opposite ribroad 6A (item 1), an unidentified structure that measures 95 by 65 feet is located in a clearing that covers approximately 27,000 square feet. A rectangular scarred area of approximately 14,000 square feet extends from the intersection of the perimeter road and rib road 3B (item 2). A linear scar 130 feet long by 45 feet wide extends from the intersection of the perimeter road and rib road 2B (item 3).

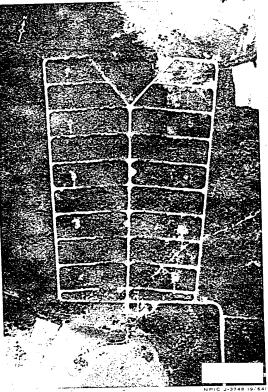
FIGURE 4. MOSCOW SAM SITE CO4-1.

An irregular clearing on the north side of the launch area (item 1) covers approximately 41,500 square feet. It contains a U-shaped probable revetment with walls that appear to be approximately 120, 50, and 120 feet long and an estimated 20 feet wide at the base. Across the road are two parallel, possibly earthen walls. Scarring parallel to rib road 9B (item 2) and extending to the perimeter road covers approximately 12,000 square feet.

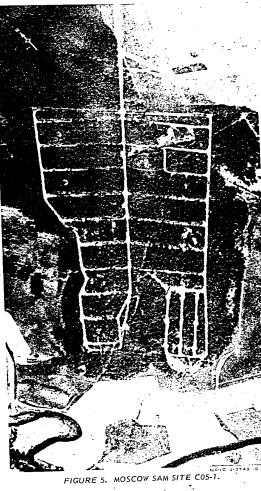
A new road was observed on February 1964 photography extending from a point between rib roads 1A and 2A to the intersection of rib road 3A with the perimeter road (item 1).

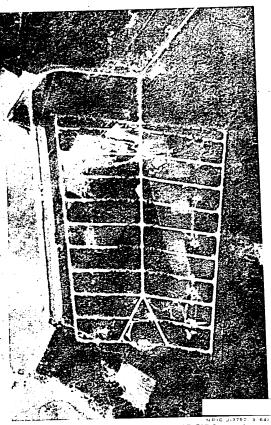
FIGURE 6. MOSCOW SAM SITE COT-1.

On photography of Mission ascarred area between rib roads 7A and 8A (item 1) and parallel to the perimeter road measured approximately 22,300 square feet. On Mission photography, a U-shaped probable revetment was identified in the area. Between ribroads 8A and 9A (item 2) scarring covered approximately 34,800 square feet

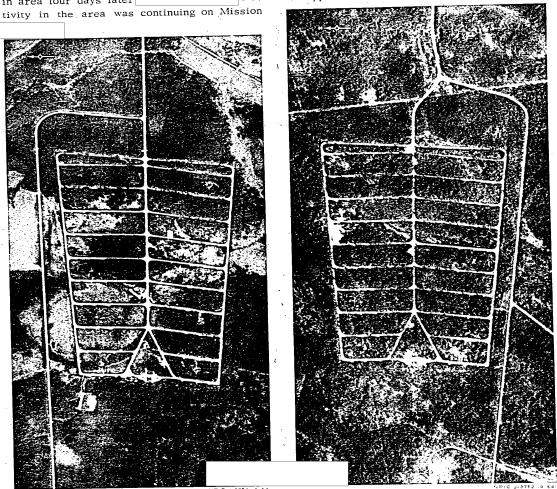
FIGURE 7. MOSCOW SAM SITE CO9-1.

Earth scarring on the east side of rib road 6B (item 1) covered 11,700 square feet when first seen, on Mission and had increased in area four days later. Activity in the area was continuing on Mission

Between rib roads 5A and 6A (item 1), two probably earthen walls are constructed parallel to one another and to the perimeter road. They are approximately 425 feet long and 70 feet apart.

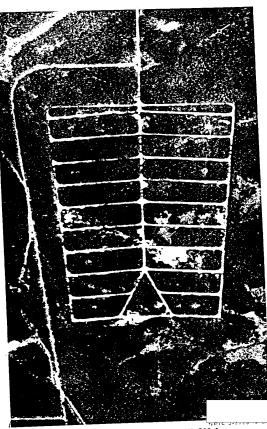
FIGURE 9. MOSCOW SAM SITE C12-1.

A scarred area between rib roads 2B and 3B (item 1) was approximately 137,000 square feet in area, Mission and contained four walls or structures, one 285 feet long, one 225 feet, and two 250 feet long. All are estimated to be 25 feet wide. The expanded by mid-July 1964 almost to rib road 2B.

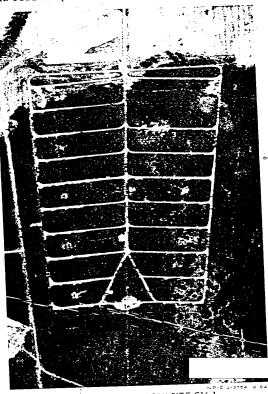
FIGURE 10. MOSCOW SAM SITE C16-1.

A curved scar extends from rib road 9A toward rib road 8A (item 1). A second cleared area (item 2) is located along the perimeter road between rib roads 7B and 8B and covers approximately 21,000 square feet. Clearings have been cut in the woods along both sides of rib road 7B (item 3).

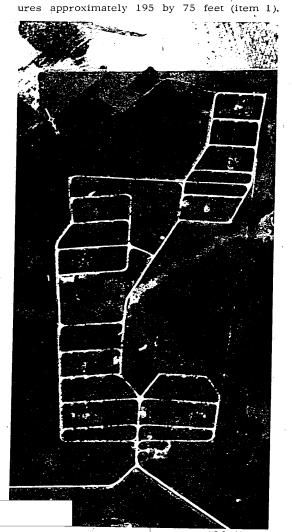
FIGURE 11. MOSCOW SAM SITE C19-1.

A rectangular scarred area at the intersection of rib road 5A and the centerline road is 300 by 155 feet (item 1). Outside the perimeter road at the southeast corner (item 2), a cleared area measures 490 by 140 feet. On the scarring had extended east-

ward an additional 150 feet.

A shallow cut or excavation at 6A3 meas-

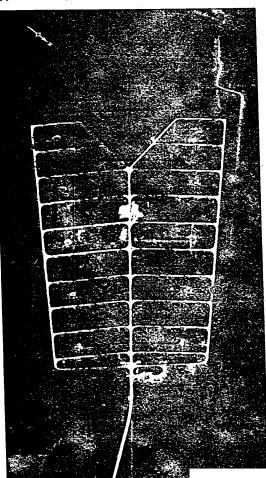
FIGURE 13. MOSCOW SAM SITE C22-1.

Scarring along both sides of the centerline road between rib roads 6 and 7 (item 1) covers approximately 60,000 square feet.

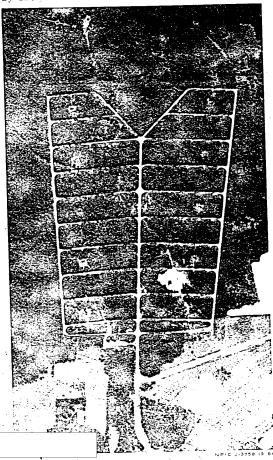
FIGURE 14. MOSCOW SAM SITE C24-1.

A four-sided revetment in a 120,000-square-foot clearing between rib roads 2B and 3B (item 1) has openings on the east and west sides for roads connecting it with the rib roads. The revetment is approximately 220 feet long by 115 feet wide.

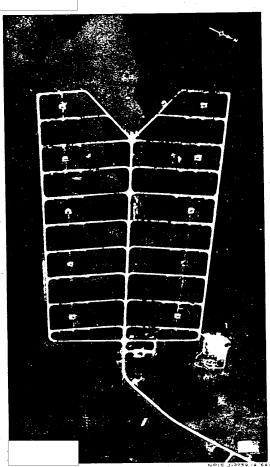
FIGURE 15. MOSCOW SAM SITE C25-1.

A large scarred area at the northeast corner of the launch area (item 1) covered approximately 100,000 square feet when photographed and the scarring had increased eastward an additional 30,000 square feet by

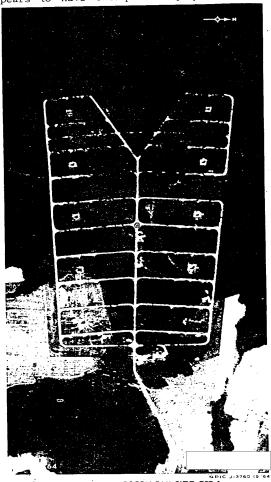
FIGURE 16. MOSCOW SAM SITE C27-1.

A curved, scarred area near the perimeter road between rib roads 2A and 3A is approximately 370 feet long by 110 feet wide. On photography from Mission the scar appears to have two parallel possible walls.

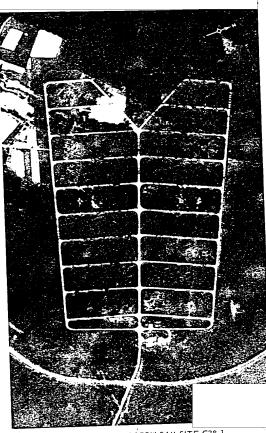
FIGURE 17. MOSCOW SAM SITE C28-1.

Scarring inside the perimeter road between rib roads 8A and 9A (item 1) contains a revetment that is approximately 360 feet long, 120 feet wide, and has walls estimated to be 28 feet wide at the base. Across the perimeter road (item 2), a U-shaped revetment is in a scarred area of approximately 59,000 square feet. The reverment is 80 by 95 by 80 feet, with walls

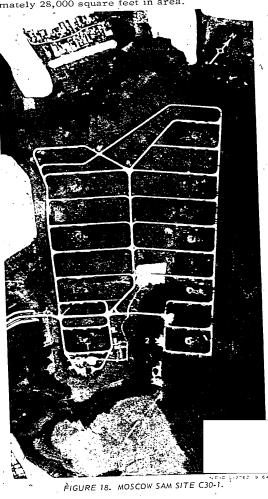
Parallel to both sides of rib road 3B (item 1) the earth is scarred for approximately 460 by A second area (item 2), along the 375 feet. perimeter road south of rib road 1B, is approximately 28,000 square feet in area.

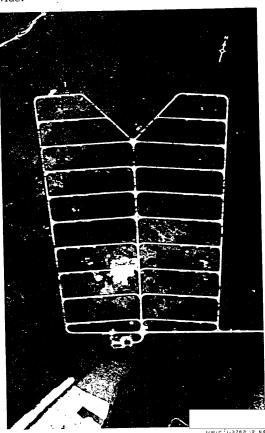
FIGURE 19. MOSCOW SAM SITE C33-1.

A linear scar (item 1) along the perimeter road at the north-northwest corner of the launch area is approximately 145 feet long by 100 feet wide.

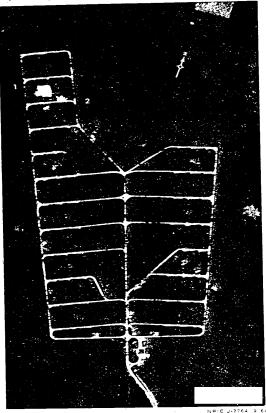
FIGURE 20. MOSCOW SAM SITE C35-1.

Between rib roads 10A and 11A (item 1) an earthen wall appears to have been constructed by pushing earth up from opposite sides. Scarring covers an area of approximately 330 by 185 feet, and the probable wall is about 215 feet long and 20 feet wide at the base. Immediately south of this area, along rib road 10A (item 2), a second scarred area covers approximately 15, 475 square feet.

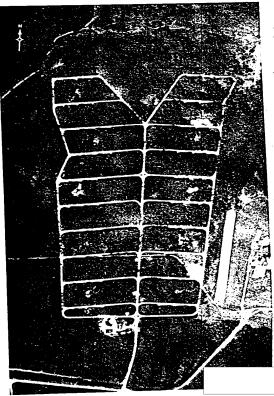
FIGURE 21. MOSCOW SAM SITE C36-1.

A scarred area of approximately 58,500 square feet between rib roads 8B and 9B (item 1) contains one probable rectangular revetment 145 feet long by 25 feet wide and a possible revetment 85 feet long by 20 feet wide. Adjacent to the perimeter road, between ribroads 2B and 3B (item 2), is a scarred area of approximately 59,500 square feet. A probable low earthen wall on the south side of this area measures approximately 165 feet long

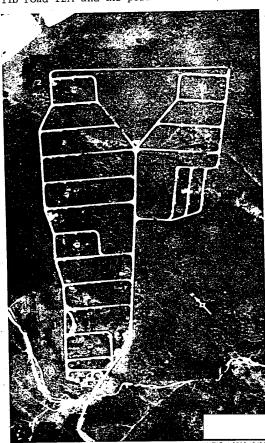
FIGURE 23. MOSCOW SAM SITE E02-1.

Photography revealed a curved ground scar between rib roads 2A and 3A (item 1). the area had developed into a square clearing of approximately 41,600 square feet. A second area had been cleared since September 1963, at the intersection of rib road 12A and the perimeter road (item 2).

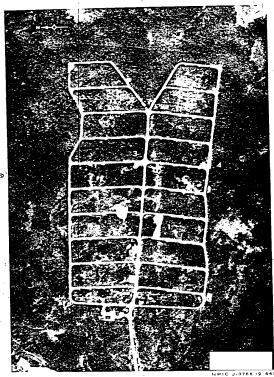
FIGURE 24. MOSCOW SAM SITE E03-1.

An area of scarring between rib roads 3B and 4B is approximately 490 feet long by 150 feet wide (item 1). On both sides of rib road 4A (item 2) there is a scarred area that measured approximately 36,600 square feet and had expanded to 38,000 square

feet At the intersection of rib road 6A and the centerline road (item 3) scarring covers approximately 12,445 square feet; and at the intersection of 6B and the perimeter road (item 4) a scar covers approximately 9,700 square feet.

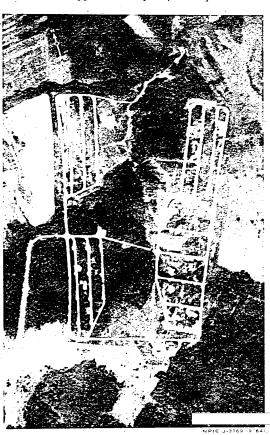
FIGURE 25. MOSCOW, SAM SITE E04-1.

This atypical site has two areas of ground scarring that are new since September 1963. The larger (item 1) is along both sides of a rib road in the northwest corner of the launch area and covers approximately 93,600 square feet. A smaller scar (item 2) is inside the perimeter road in the southeast corner of the launch area and covers approximately 21,800 square feet.

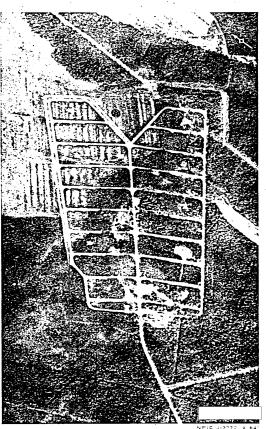
FIGURE 26. MOSCOW SAM SITE E06-1.

A light-toned scarred area is situated between rib roads 1B and 2B along the centerline road (item 1) and covers approximately 52,200 square feet.

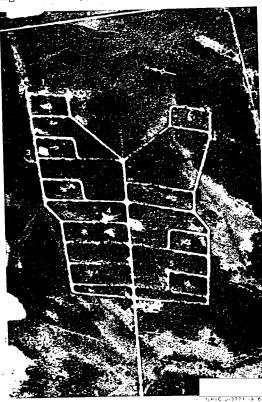
FIGURE 27. MOSCOW SAM SITE E07-1.

Five areas of scarring are located by item numbers as follows: 1) an area of 8,750 square feet along the perimeter road in the northeast corner; 2) a second area, immediately south of item 1, is approximately 14,400 square feet; 3) an area between rib roads 7A and 8A adjacent to the perimeter road is approximately 23,250 square feet; 4) a clearing between 4A and 5A is approximately 27,000 square feet; and 5) a clearing at 2B is approximately 8,800 square feet.

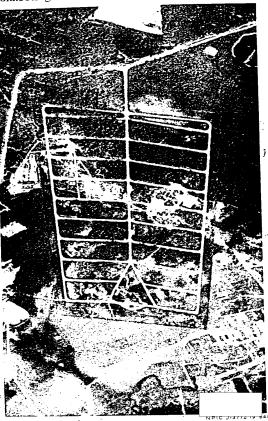
FIGURE 28. MOSCOW SAM SITE E08-1.

A clearing was first observed on the west side of rib road 5B (item 1) on photography of and a U-shaped revetment was apparent in the clearing on photography

The revetment measures approximately 110 by 190 by 115 feet, with walls estimated to be 15 feet wide at the base. A probable road has been constructed since September 1963, connecting rib roads 5A and 6A (item 2).

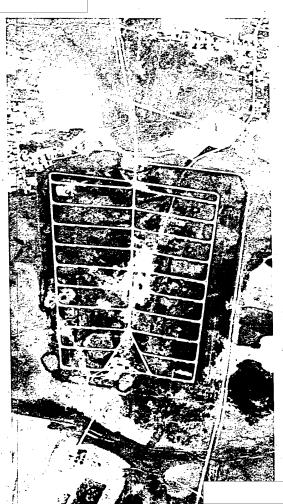
FIGURE 29. MOSCOW SAM SITE E10A-1.

New scarring was apparent between rib roads 5B and 6B (item 1) on photography of

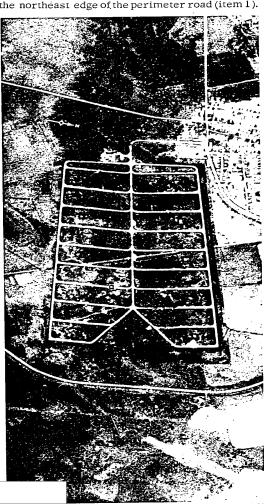
FIGURE 30. MOSCOW SAM SITE E10-1.

An area of scarred earth that covers approximately 14,000 square feet lies just inside the northeast edge of the perimeter road (item 1).

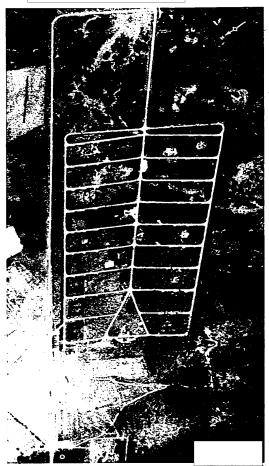
FIGURE 31. MOSCOW SAM SITE E12-1.

Between rib roads 3A and 4A (item 1), a scarred area that covered approximately 14,000 square feet had expanded to approximately 17,800 square

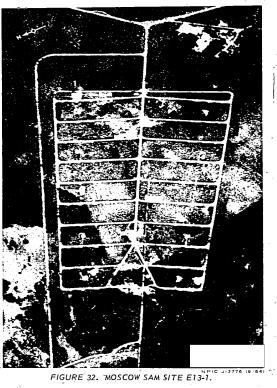
A clearing lies between 9A2 and the perimeter road (item 1) and covers an area of approximately 22,100 square feet. On photoga revetment that measraphy ures approximately 85 by 35 feet was discernible in the clearing. At the intersection of the centerline road and rib road 7A (item 2), another scarred area covers approximately 26,500 square feet. A third area of disturbed earth lies on both sides of the centerline road between rib roads 2 and 3 (item 3), and covers approximately 18,300 square feet.

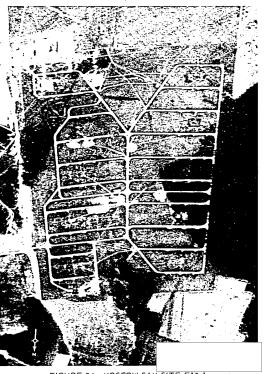
FIGURE 34. MOSCOW SAM SITE E15-1.

There is a rectangular excavation approximately 185 feet long by 135 feet wide on the north side of rib road 9A (item 1), and adjacent to it is a second rectangular possible excavation (item 2) that measures 150 by 115 feet. A scarred area of 11,475 square feet lies between rib roads 5A and 6A (item 3), and opposite it, parallel to 5A (item 4) is another area that covers approximately 35,200 square items 3 and 4 had expanded to cover an area of approximately 73,000 square

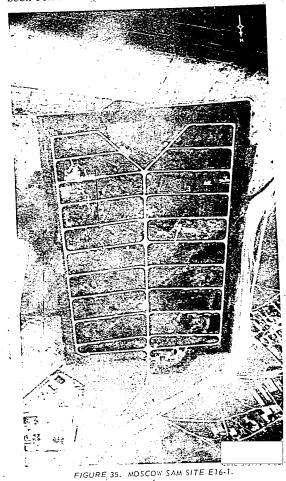
Outside the perimeter road, opposite rib road 9A (item 1), scarring covers approximately 19,000 square feet. Previously reported structures 5/ at 4B1 (item 2) and 7B1 (item 3) had been removed by late June 1964.

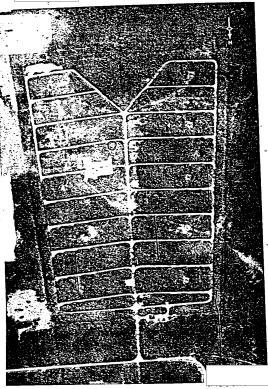
FIGURE 36. MOSCOW SAM SITE E17-1.

Parallel to the perimeter road and outside the southeast corner of the launch area, scarring covers approximately 72,000 square feet (item 1). A large scarred area lying on both sides of rib road 6A (item 2) covered approximately 138,000 square feet and had expanded to approximately 156,450 square feet Additional scarring along the centerline road between rib roads 4B and 5B covered approximately 15,600 square feet photography (item 3).

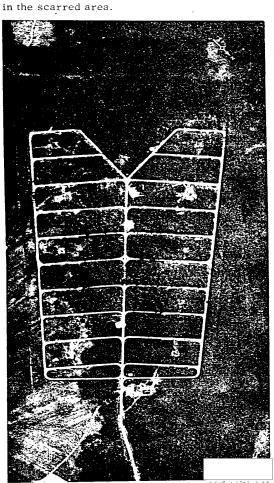
FIGURE 37. MOSCOW SAM SITE E18-1.

Along the centerline between rib roads 7B and 8B (item 1) earth scarring covers approximately 22,800 square feet.

a possible U-shaped revetment was apparent

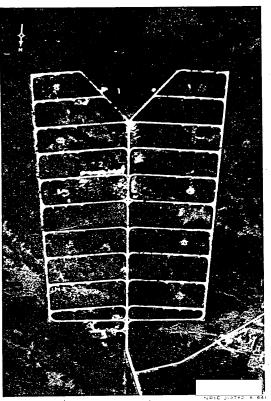
FIGURE 38. MOSCOW SAM SITE E19-1.

A small scarred area outside the perimeter road near rib road 9A (item 1) is approximately 6,375 square feet in area. Another scar extends from the vicinity of the centerline road to a point opposite 6Al (item 2) and measures approximately 665 by 90 feet. Within the scarred area, along the south edge of the rib road, there is a probable earthen wall that measures approximately 425 feet long and is estimated to

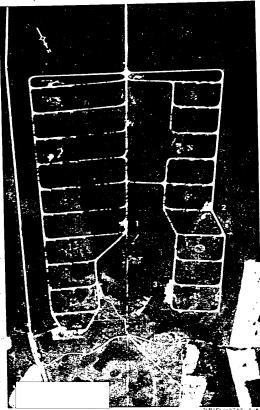
FIGURE 39. MOSCOW SAM SITE E20-1.

Adjacent to the centerline road between rib roads 4A and 5A (item 1) there is scarring approximately 6,750 square feet in area, and at the intersection of rib road 4B and the perimeter road there is another scar which covers 10,900 square feet (item 2). Extending along the perimeter road to rib road 1B there is a scar approximately 470 feet long by 105 feet wide (item 3).

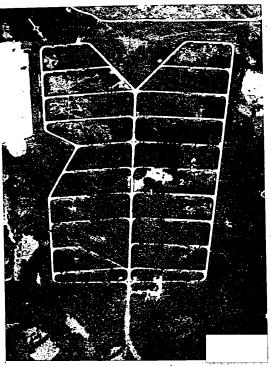
FIGURE 40. MOSCOW SAM SITE E22-1.

A building 130 by 55 feet, located between rib roads 4B and 5B (item 1), may have been present in June 1963 but obscured by vegetation. Also between 4B and 5B (item 2) there is scarring covering approximately 58,000 square feet and containing a probable revetment under construction. Preliminary measurements indicate that one side of the probable revetment is 415 feet long and the other is 230 feet long.

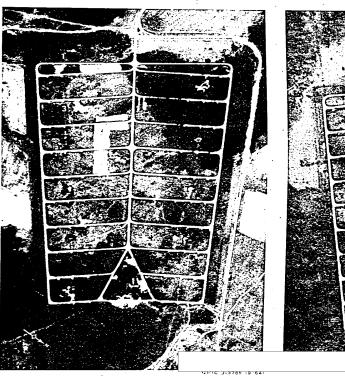
FIGURE 41. MOSCOW SAM SITE E23-1.

Two scarred areas lie between rib road 9A and the perimeter road, one being approximately 20,500 square feet (item 1), and the other 70,000 square feet in area (item 2). Between 7A and 8A (item 3) there is a scar measuring approximately 250 by 145 feet. L-shaped scarring between 5A, 6A, and 7A (item 4) consists of a probable road constructed on a fill, forming the stem. A wall or fence approximately 480 feet long, parallel to 7A, forms the base. Some scarring is evident opposite 3A1 (item 5), and covers approximately 11,500 square feet.

Between rib roads 5B and 6B along the centerline road (item 1), a scar covering approximately 85,000 square feet contains a rectangular revetment under construction. The revetment measures 260 by 140 feet and has walls that are estimated to be 30 feet wide at the base. There is another small scar between rib road 9A and the perimeter road (item 2).

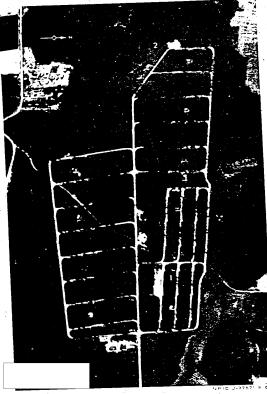
FIGURE 43. MOSCOW SAM SITE E26-1.

A scarred area parallel to a launch rib road north of the centerline road (item 1) is approximately 26,600 square feet in area. It contains a rectangular revetment approximately 380 feet long by 70 feet wide, with walls that are approximately 25 feet wide at the base. Scarring along the perimeter road at the west end of the launch area (item 2) contains a probable rectangular revetment which is approximately 160 by 95 feet with walls estimated to be 28 feet wide at the base.

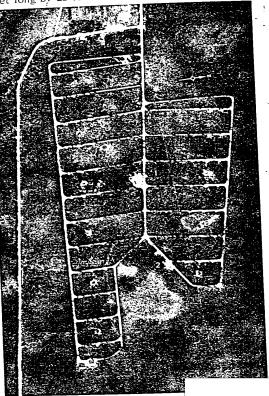
FIGURE 44. MOSCOW SAM SITE E27-1.

Between rib roads 7A and 8A along the centerline road (item 1) the earth is scarred for approximately 23,750 square feet. At the junction of rib road 1B and the perimeter road (item 2) scarring covers approximately 14,500 square feet. Between rib road 12A and the perimeter road (item 3) earth scarring covers approximately 20,000 square feet through which there is a linear ditch or cut connecting the roads. The cut or ditch is approximately 170 feet long by 25 feet wide.

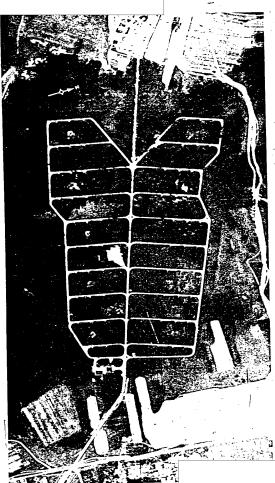
FIGURE 45. MOSCOW SAM SITE E28-1.

A clearing between rib roads 4A and 5A (item 1) is approximately 77,000 square feet in area and contains a revetment that measures 280 by 85 feet and has walls estimated to be

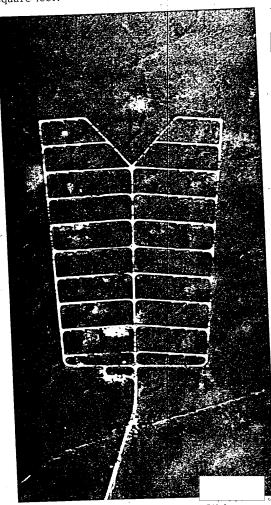
FIGURE 47. MOSCOW SAM SITE E31-1.

An area of scarring between rib roads 1A and 2A (item 1) covers approximately 67,200 square feet.

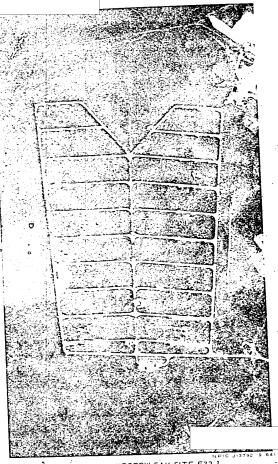
FIGURE 48. MOSCOW SAM SITE E32-1.

A curved scar between rib roads 3A and 4A along the perimeter road (item 1) is approximately 71,400 square feet in area. Within it there is a rectangular revetment approximately 265 by 90 feet with narrow entrances at both ends. The walls are estimated to

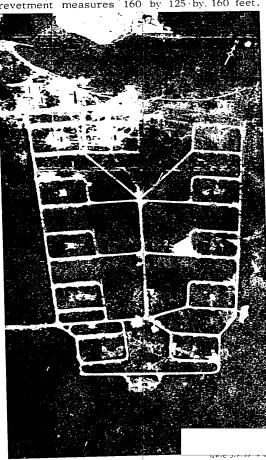
FIGURE 49. MOSCOW SAM SITE E33-1.

A scarred area north of rib road 9A contains two low earthen walls (item 1). Scarring covers approximately 30,000 square feet. A U-shaped revetment has been constructed between rib roads 5B and 6B (item 2), in a cleared area of approximately 57,500 square feet. The revetment measures 160 by 125 by 160 feet.

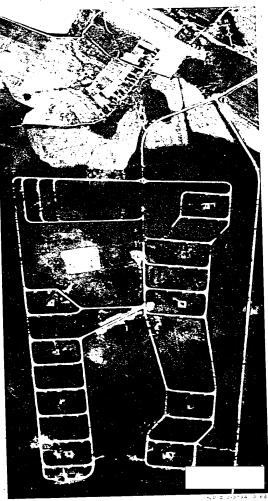
FIGURE 50. MOSCOW SAM SITE E34-1.

At the center of the launch area (item 1) scarring parallels both sides of the perimeter road for approximately 1,065 by 225 feet.

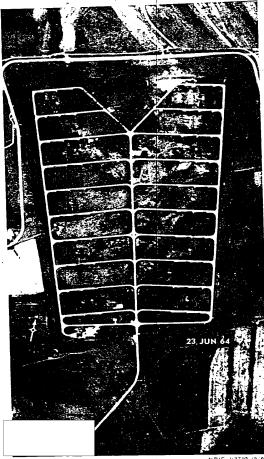
FIGURE 51. MOSCOW SAM SITE E35-1.

Scarring along the perimeter road at the northeast end of the launch area (item 1) covers approximately 45,000 square feet. Within it, a generally L-shaped earthen wall measures 280 by 170 feet. A possible environmental shelter is at position 2A1 (item 2).

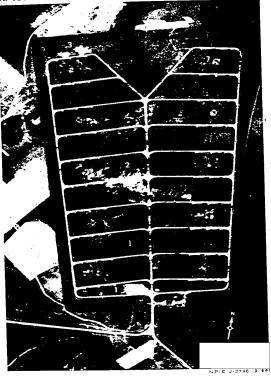
FIGURE 52. MOSCOW SAM SITE E36-1.

A rectangular scar approximately 58,845 square feet in area lies between the perimeter road and rib road 1A (item 1). It contains a probable revetment under construction, with walls on the east and west ends that are approximately 100 by 190 feet long, respectively. Along both sides of rib road 5A (item 2) earth scarring covers approximately 62,800 square feet. Adjacent to the perimeter road on the west side there are two U-shaped probable revetments (item 3), one of which is 120 by 20 by 120 feet, and the other is 80 by 20 by 80 feet.
